Restricted
Technical Report
RP/1981-1983/4/7.6/04

National Museum of Somalia, Mogadiscio: Roof Restoration Project

NATIONAL MUSEUM OF SOMALIA,
MOGADISCIO :
Roof Restoration Project

Technical Report
RP/1981-1983
FMR/CLT/CH/82/160(Lengyel)
1 October 1982

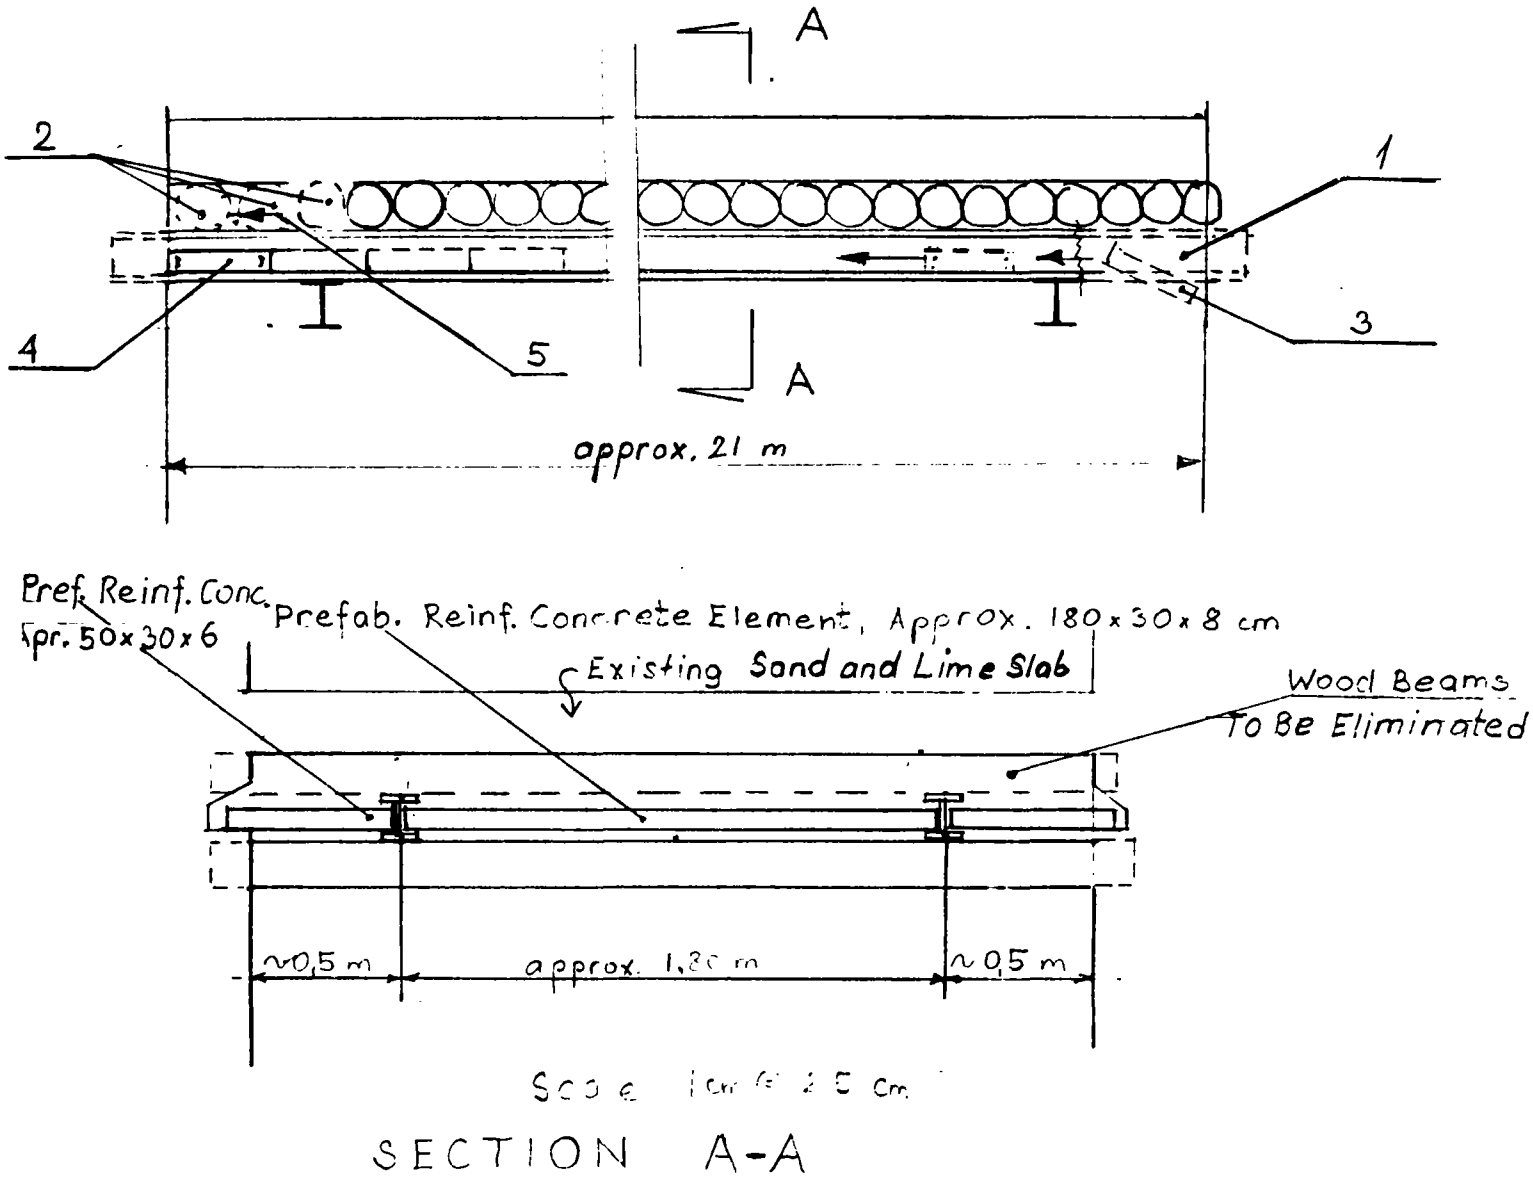
11. Recommended procedure for reinforcing and changing the ceiling on the ground floor open-sided corridor

8. The wooden ceiling in the open corridor is damaged by termites between 10% to 80% in its substance, depending on its location, so far as it is possible to judge viewed from below. The worst damage occurs in the section of the corridor nearest to the street. The wooden ceilings of the adjoining rooms and the library seem to be in better shape than the one on the corridor. Their replacement does not seem to be necessary at this time.

- i) Cut out a length of 40 cm. of existing I beams at either end of the corridor.
- ii) Eliminate 3 or 4 wooden beams at opposite end of corridor.
- iii) Slide in through cutout in I beams prefabricated reinforced concrete element.
- iv) Slide prefabricated reinforced concrete element all the way to the other end of the corridor on the lower flanges of I beams.
- v) Fill up space between element and existing floor with lightweight concrete to ensure complete support.
- vi) Install replica of wooden beam ceiling below new concrete elements to recreate original appearance.
- vii) Repeat sequence 2, 3, 4, 5 until completion.

NOTE: Verify I beams load carrying capacity before adding this additional weight. Install new cross I beam, if calculation shows it is necessary to strengthen the structure.

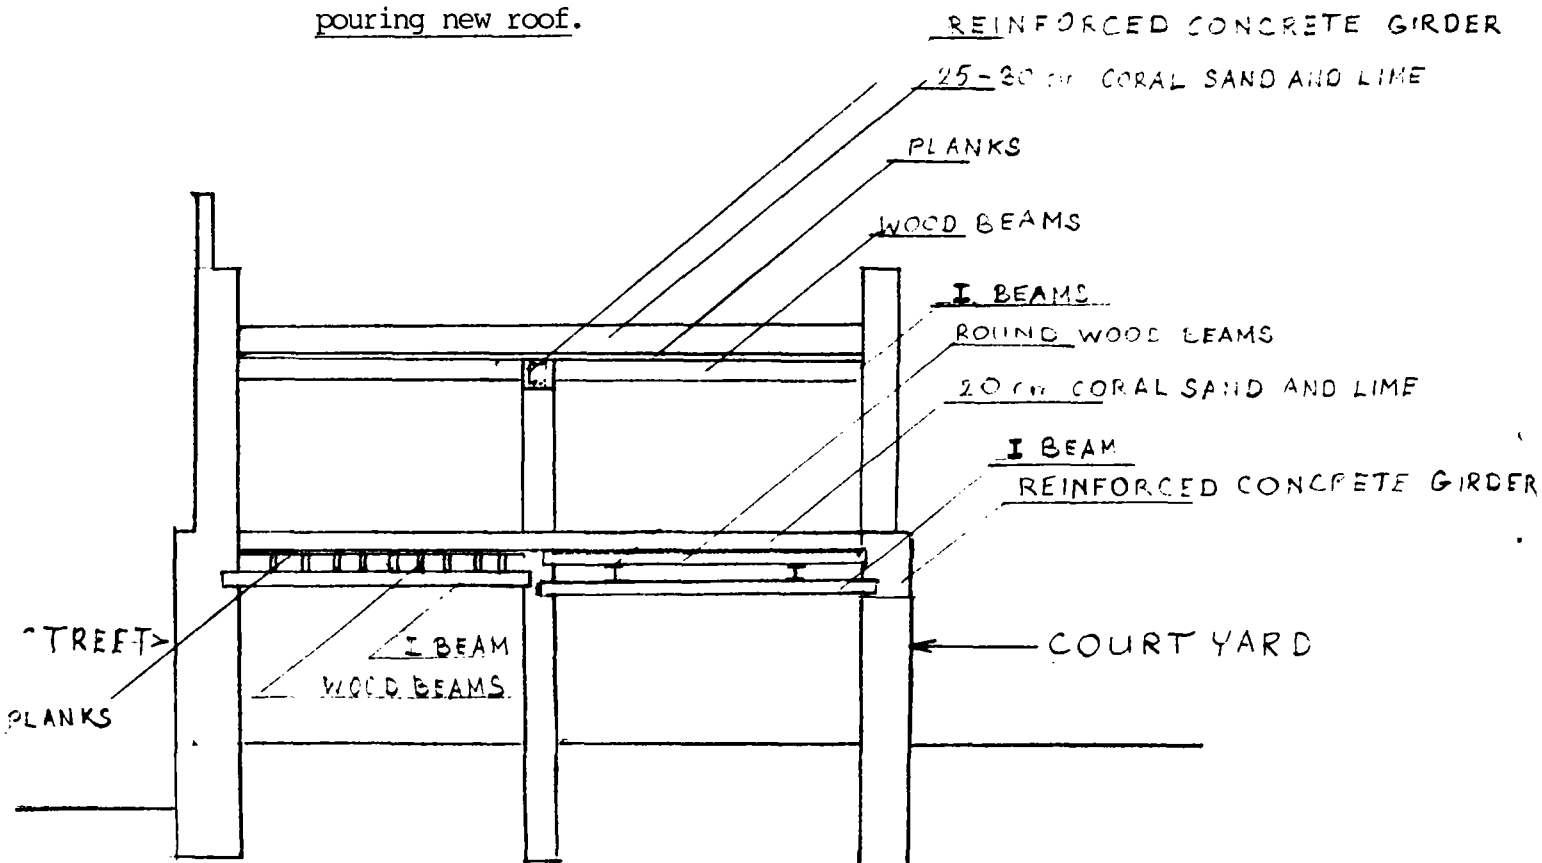
TYPICAL
CROSS SECTION

15. The roof is not waterproof. The coral sand and lime agglomerate must have been watertight in the first decades of its existence, but as it has been baked continuously by the sun, it developed cracks and was repaired again and again by layers of lime and layers of cement.

16. The only safe way of repairing the roof is by replacing it completely by a self-supporting reinforced concrete slab and waterproofing. The restoration should start with the concrete roof and proceed towards the interior in order to provide protection for the building, before carrying out the restoration of the interior.

19. The wooden beams and the planking have to be replaced partially or completely, depending in what condition they appear to be when the roof above them will be demolished. If they are to be reutilized, they should be chemically treated against termites. Any new wood in the restoration should be termite-resistant. The composition of the roof should be as on page 6.

- i) Erect temporary protection over a section of the roof.
- ii) Break up roof on a section of not more than 5 metres.
- iii) Dispose rubble through chute on street side.
- iv) Clear and examine surface of wooden planks after eliminating rubble.
- v) If wooden elements are not in perfect condition, mark them below; from the inside of the building, but do not remove yet.
- vi) Paint or spray twice all wood with anti-termite chemical solution from roof.
- vii) Cover wood with protective waterproof sheeting.
- viii) Place reinforcing steel and pour concrete and proceed to next section.
- ix) After curing concrete, place 10 cm. thick pumice heat insulation; (when the whole roof is finished).
- x) Place paper vapour barrier.
- xi) Lay two-ply bituminous felt waterproofing.
- xii) Only now remove damaged wooden elements from inside and replace them with new ones after anti-termite treatment.
