# The Restoration of Borobudur

Published in 2005 by the United Nations Educational,  
Scientific and Cultural Organization  
7, place de Fontenoy F-75352 Paris 07 SP

Towards an International Project, Studies on the Sources and Causes of Decay, Execution of the Project, The Post-Restoration Development Plan, and A New Perspective on Some Old Questions Pertaining to Borobudur, the last chapter contributed by Prof. (Em.) Caesar Voûte.

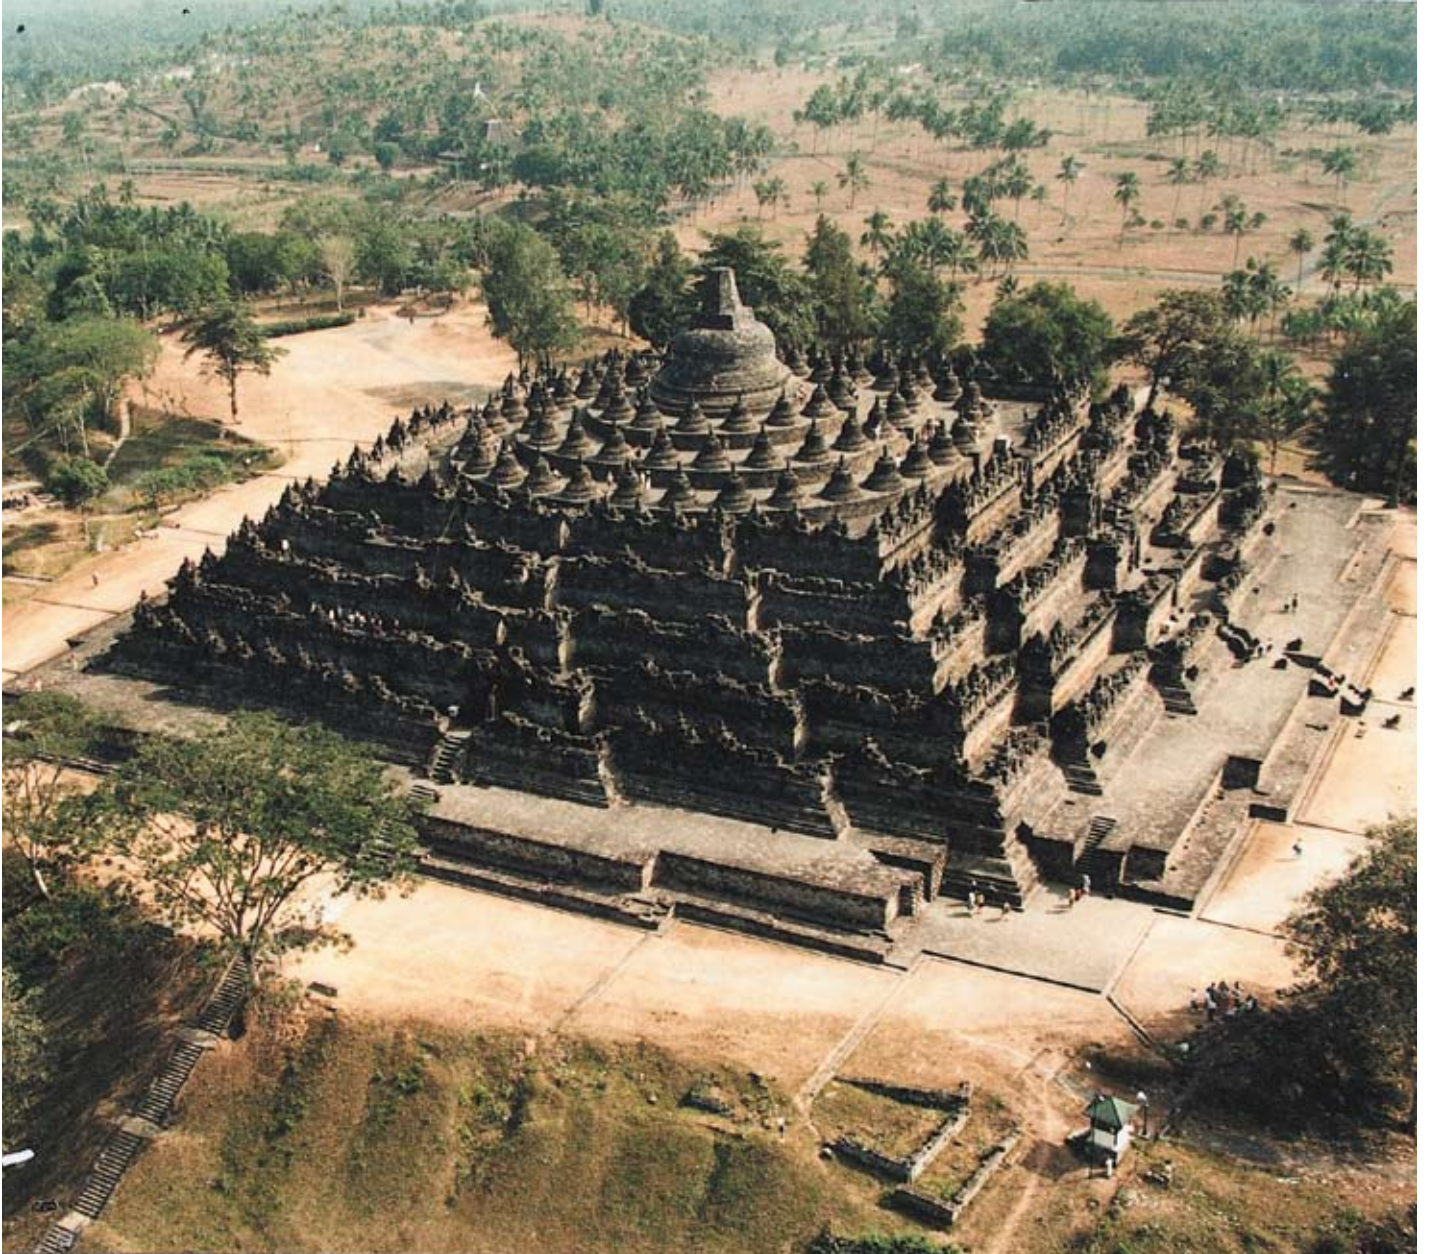
**Photo 2.5.1**  
**The ten levels of Borobudur**  
Source: Suparno

A stepped pyramid always consists of an odd number of terraces. Chandi Borobudur, however, has ten. The explanation may be that the designer of the monument had not only the indigenous tradition in mind, but – perhaps even more – the Mahayana path of the Bodhisattva. This daring break with tradition is a further demonstration of the high esteem of the founder of Chandi Borobudur for the forefather whom he identified with the Buddha. And a stepped pyramid with a stupa on top was a most appropriate symbol to depict the virtue the dynasty had accumulated successively along the Path of the Bodhisattva (Photo 2.5.1).

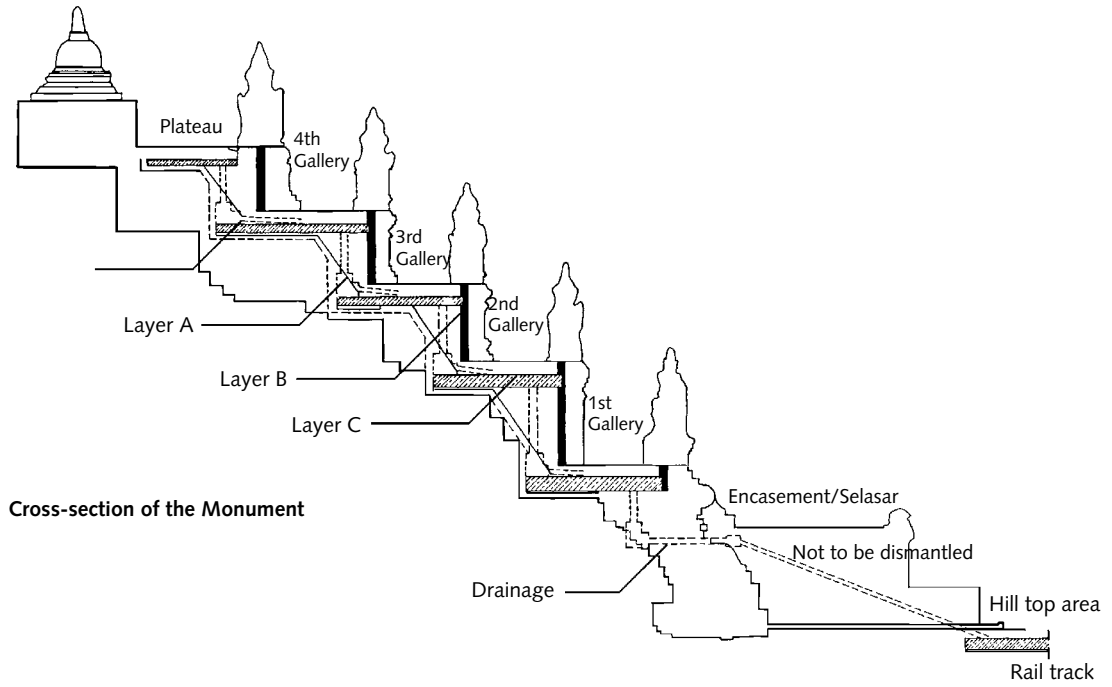
**Figure 4.2.3**  
**Drainage pipes and floor stones**  
 Source: Borobudur Restoration Project

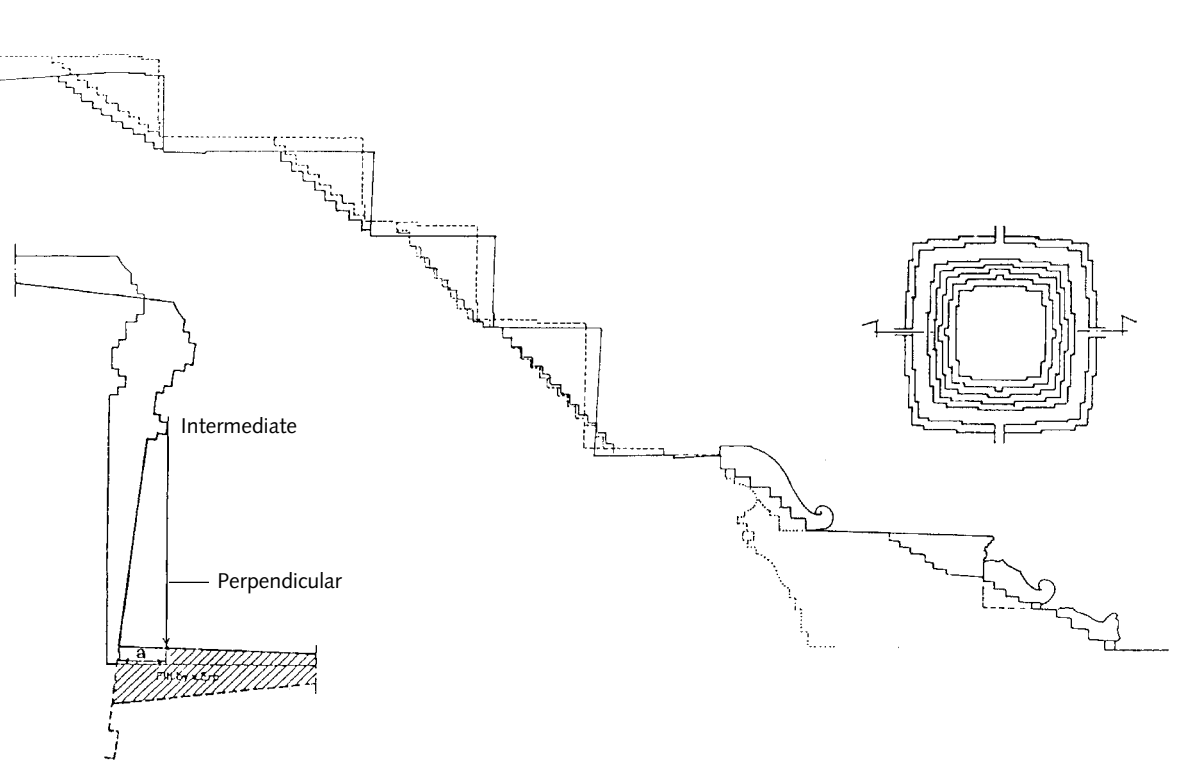
**Photo 5.4.2**  
The angle of deformation

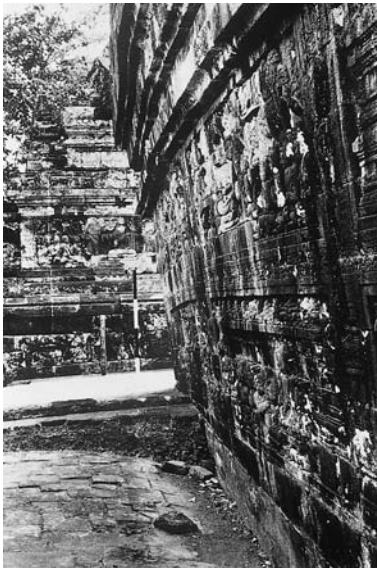
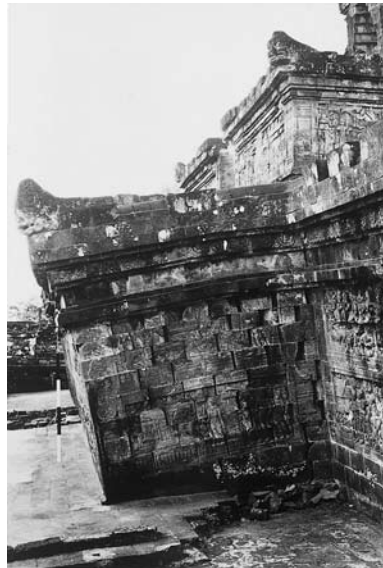
**Photo 5.4.1**  
Walls

took place behind the wall and that the cause was the alternating swelling and shrinkage of the subsoil.

When in 1959 a suspicious bulging was detected in the middle part of the wall under observation, indicating that there was not only movement in the subsoil but even a push from behind the wall, the Archaeological Service was faced with the risk of being taken by surprise by a sudden collapse. To establish the actual danger of the bulging process through continuous observation would take years and probably even decades. Since it was impossible to predict the moment when the bulging would create immediate danger, the Archaeological Service could no longer take responsibility for the safety of this national pusaka, recognized as a monument for all humanity.

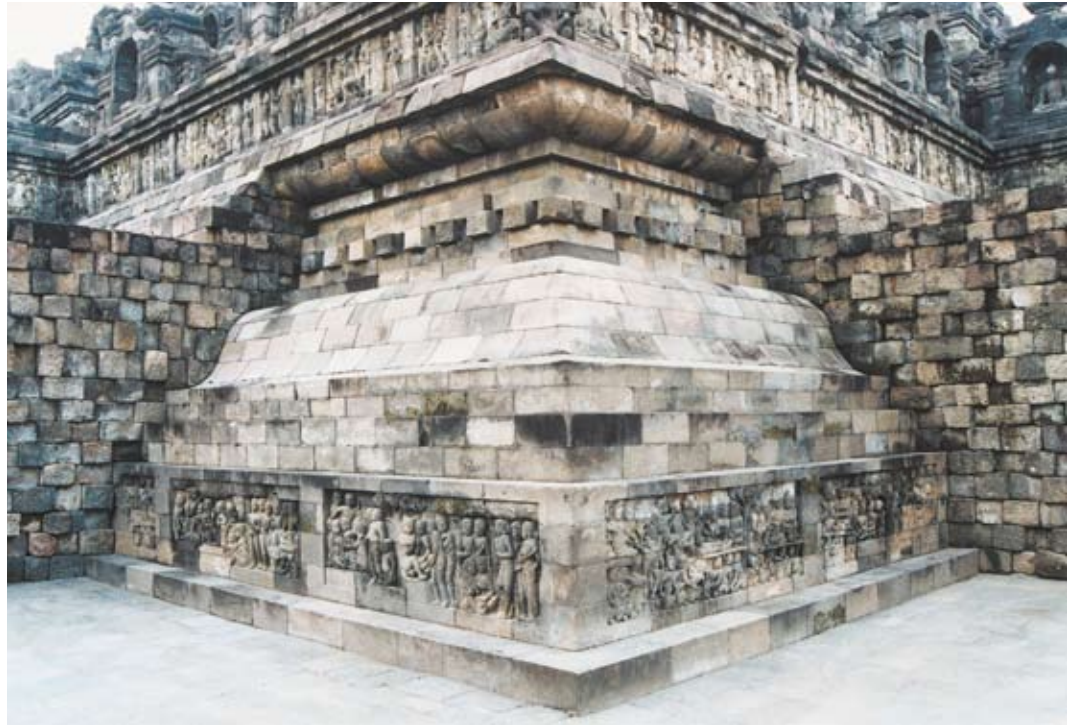
**Photo 5.5.1**  
The base of the monument measures about 118 m, the top stands at present 36 m above the foot of the monument. The pinnacle of the central stupa is incomplete.

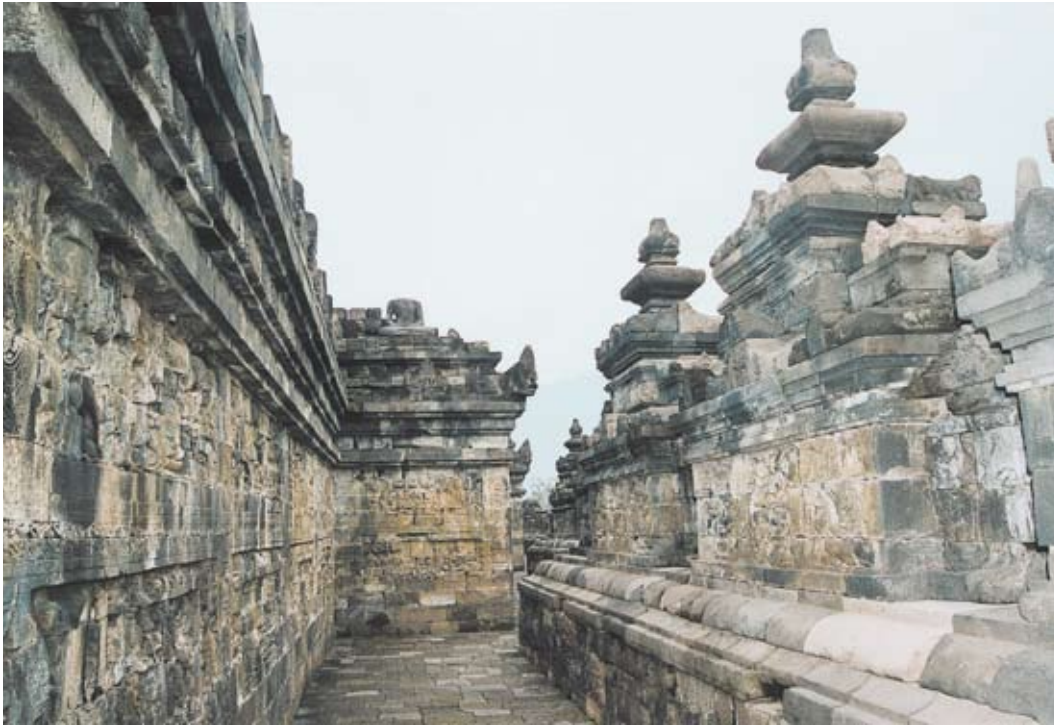
Photo 5.5.2

Staircases In the middle of each side of the edifice give access to the upper parts and galleries of the monument.

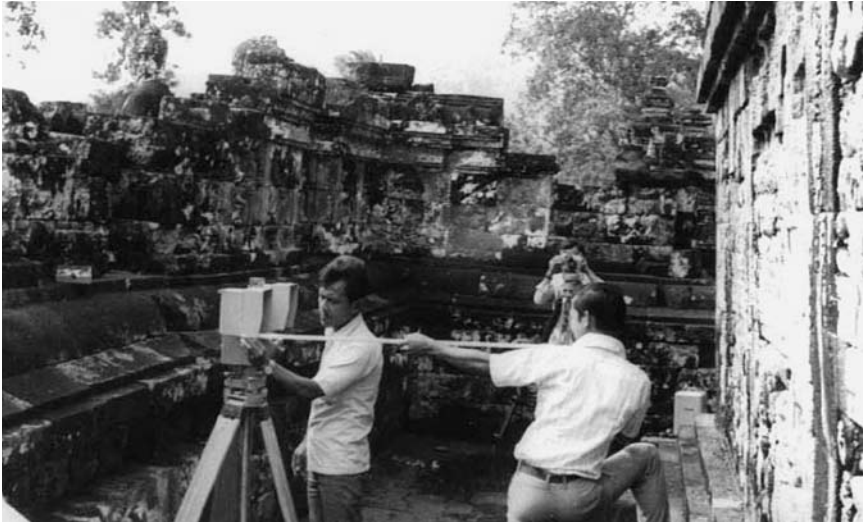
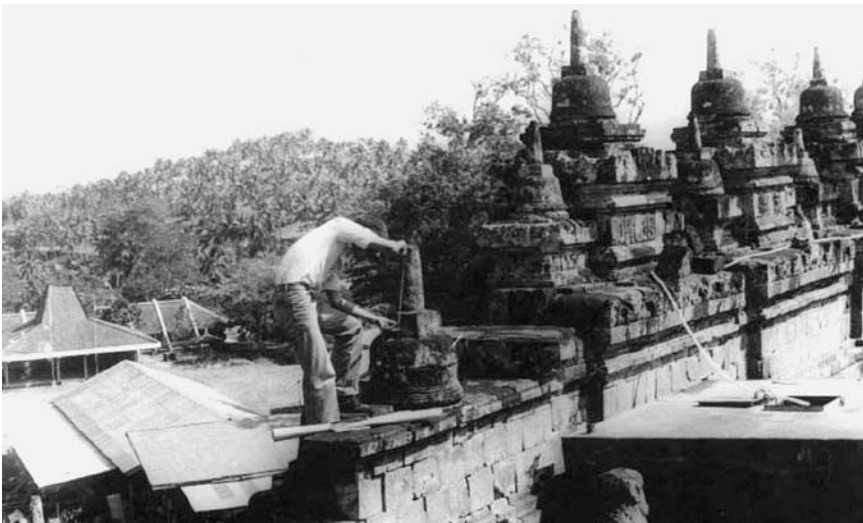
**Photo 6.1.3.2**

**Photogrammetry**

**Measuring stupa on  
balustrade**

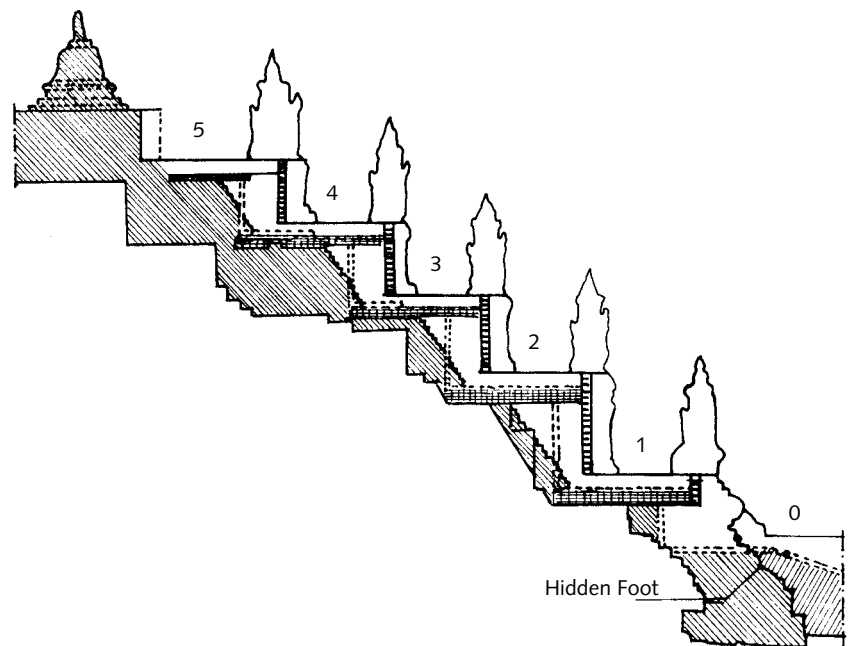
**Figure 6.1.4.1**  
Levels of construction  
Source: Borobudur  
Restoration Project

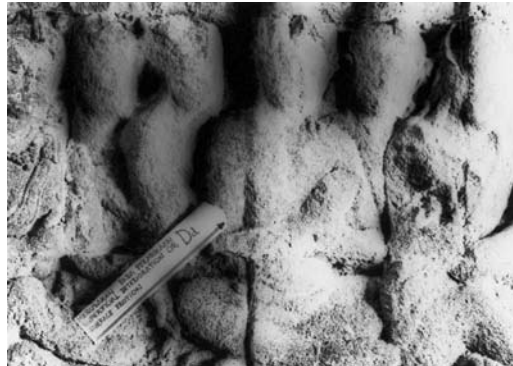
**Photo 6.1.5.2****White deposit**

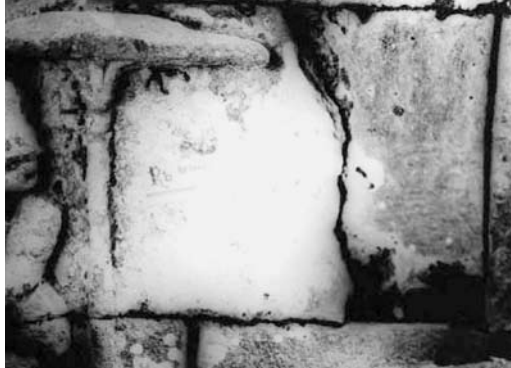
6.1.5.3

**Photo 6.1.5.3****Labelled stone**

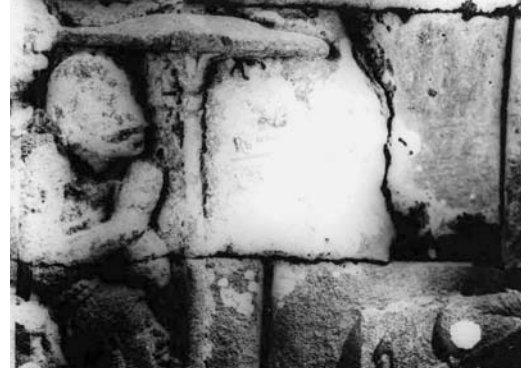
6.1.5.4

**Photo 6.1.5.4****Fissures**

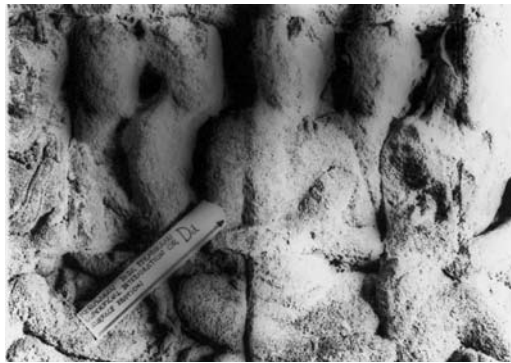
6.1.5.5

**Photo 6.1.5.5****Superficial scaling**

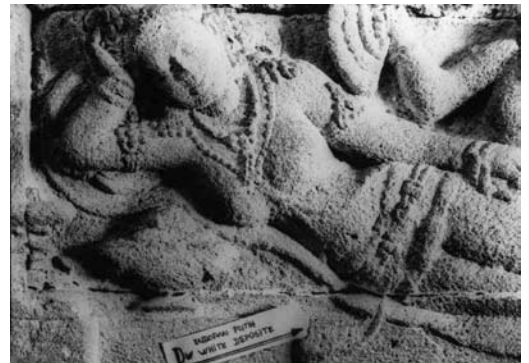
6.1.5.6

**Photo 6.1.5.6****Effloresceaes**

The mechanical process, usually called corrosion, can be divided into a biotic and an abiotic process. Organisms, as biotic factors, produce corrosive substances like organic acids that can dissolve free lime or calcium carbonate present in the material. More dangerous is the sulphuric acid produced by bacteria. Abiotic processes occur when water carrying dissolved substances – either organic or inorganic salts – permeate through the stones.

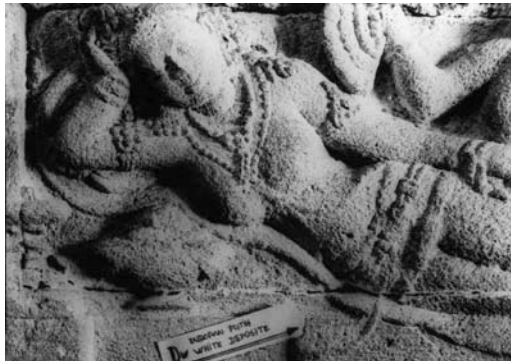
6.1.5.7

**Photo 6.1.5.7****Algae in the hollow of the relief**

Algae and lichens can be of particular importance in the soiling process, provided that water and light are present. Fungi, however, which can grow on a small amount of organic substance, can also produce disfiguring stains on the stones when humidity is high enough. Other disfiguring effects are stains and efflorescence, caused for example by iron compounds or the crystallization of salts from water that dissolves these substances and then permeates through the stones and subsequently evaporates.

The application of clay paste to the surface of stones covered with organic material was found to facilitate the cleaning operations considerably. *Hepaticae* were killed within one week (*Musci*, however, would grow on the surface of the paste). In fact, both *Musci* and *Hepaticae* were easy to remove without pre-treatment with clay paste. Algal cells decomposed after being covered with paste. White lichens (crustaceous types) were also easy to clean after contact with clay paste for one week.

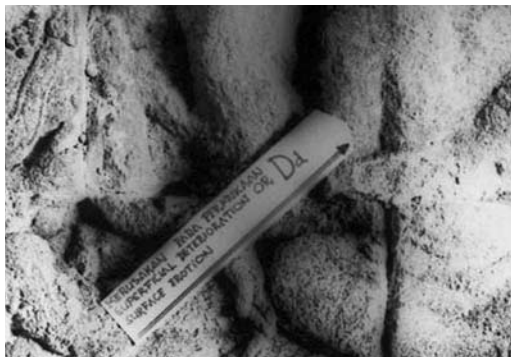
6.1.5.9

**Photo 6.1.5.9****White crustaceae lichens**

15.	Quat	1–20% 50%; Conc.	ditto	5–48 hours; 6 days	Effective for white lichens (crustaceous) and <i>Musci</i>
16.	Sodium hydroxide	5–25%	As solution		Effective for cleaning, but very corrosive.

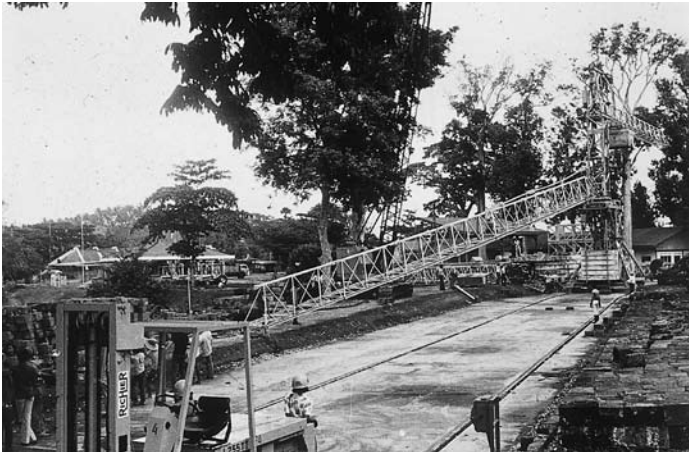
With the help of a tower crane (one per side) empty pallets were brought to the monument and loaded pallets transported to the upper work level, to await the next stage of their journey. The inner stones (which were left unmarked) were carried in pallets with no compartment dividers.

**Photo 6.2.1.1**  
Rail track of the tower crane

With a view to ensuring greater stability of the supporting hill, it was proposed that use should be made of the reinforced concrete structure that had served as the foundation of the tower crane rail track. After removal of the rail tracks, the concrete foundation was not broken up, but served instead as an additional means of strengthening the hill. Both ends of the concrete structure were connected to one another so as to form a massive ring encircling the foot of the hill. This ring was further strengthened by prestressing the concrete, through a method devised by Professor Roosseno.

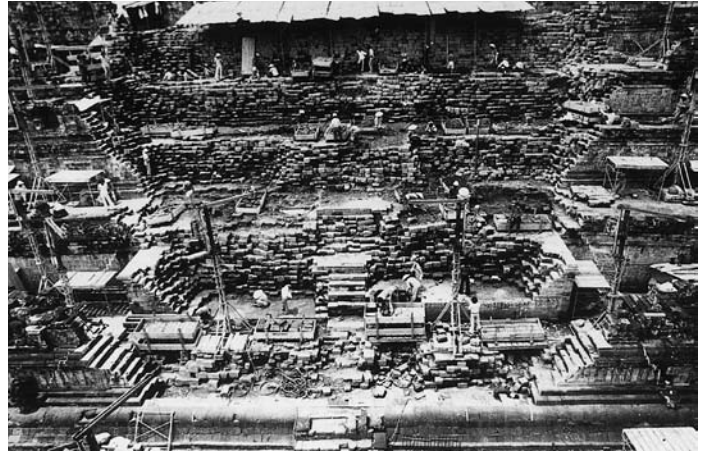
Photo 6.2.1.6

Dismantling of stones on the west side

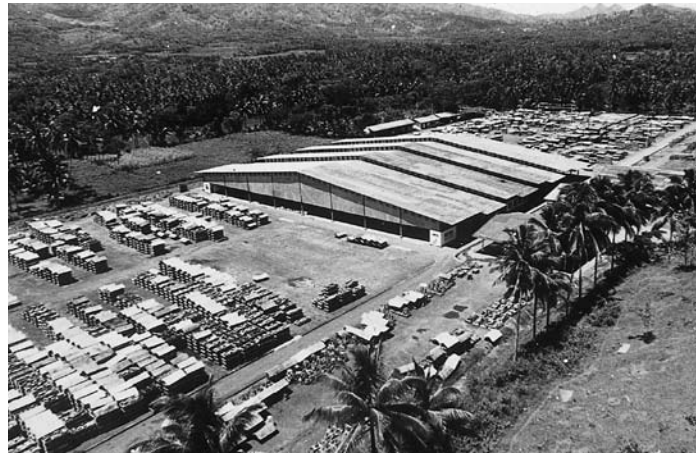
**Photo 6.2.2.1****Workshop for stone treatment**

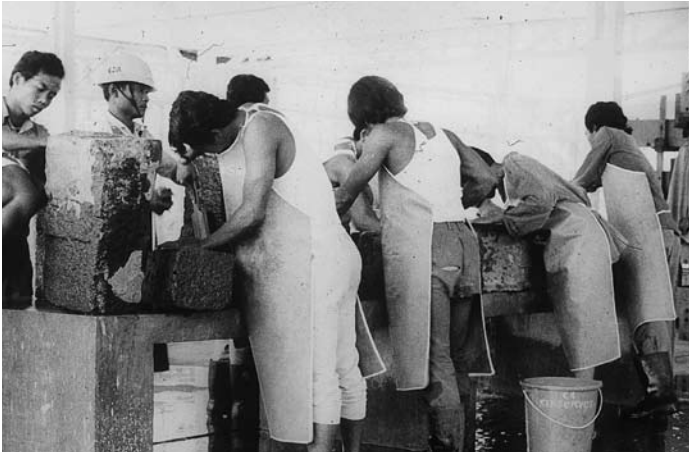
**Photo 6.2.2.4**  
Stone treatment

Clay was added to the mixture of these chemicals to make a paste. This was brushed on to the surface of the organic remains to a thickness of approximately 0.5–1 cm and left there for twenty-four hours. It was then removed by means of a spatula and the surface was brushed and rinsed thoroughly. To ensure that no more chemicals were left on the stone, the pH of the washing water was checked. If the pH measured 8 or higher, the cleaning was continued until the pH had become neutral. Treatment with AC 322 could be repeated up to a maximum of three times if necessary. The organic growth and other remains had to be totally washed away to prevent the recurrence of biological deterioration of the stones.

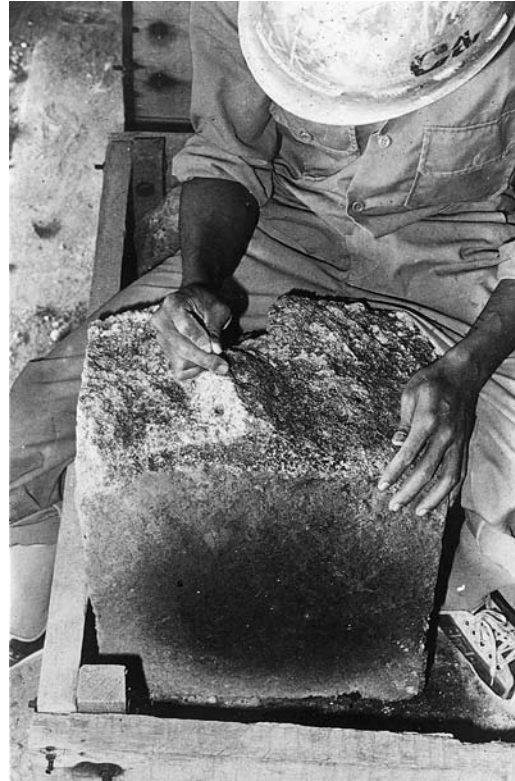
**Photo 6.2.2.6**  
Elimination of rhizomes of mosses in the pores of the stones using a fine needle

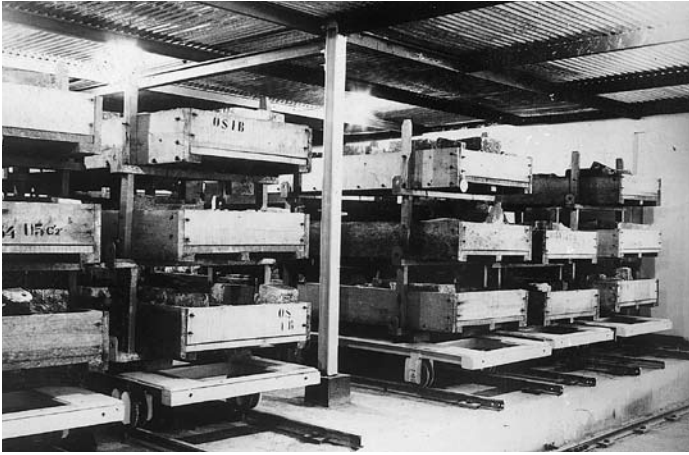
**Photo 6.2.2.7**

**Stone pallets**

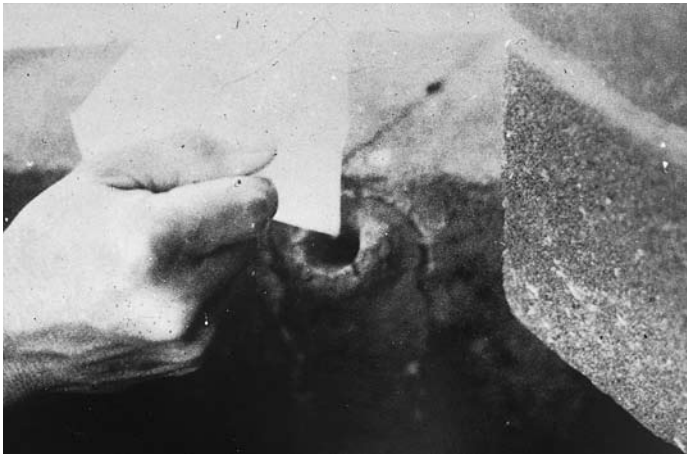
**Photo 6.2.2.10**

**Camouflage**

One final repair technique should be mentioned. This was the application of camouflage to eliminate inappropriate appearances such as pocks and seams that contrasted with the neighbouring stone surface. For this purpose

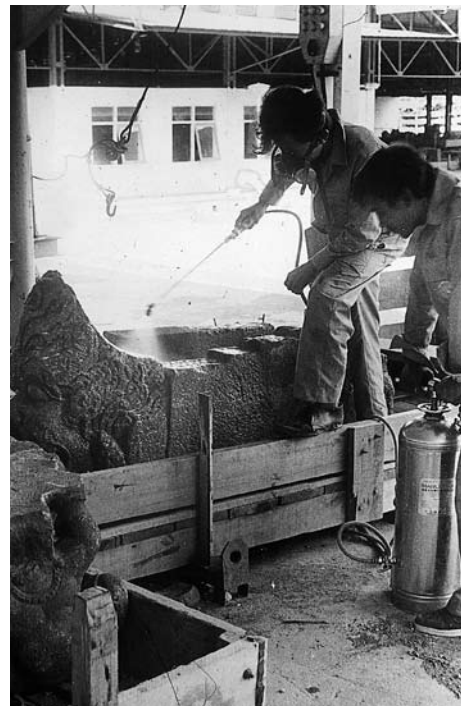
**Photo 6.2.2.11**

**Protective treatment by  
chemical pesticides with  
low concentrates**

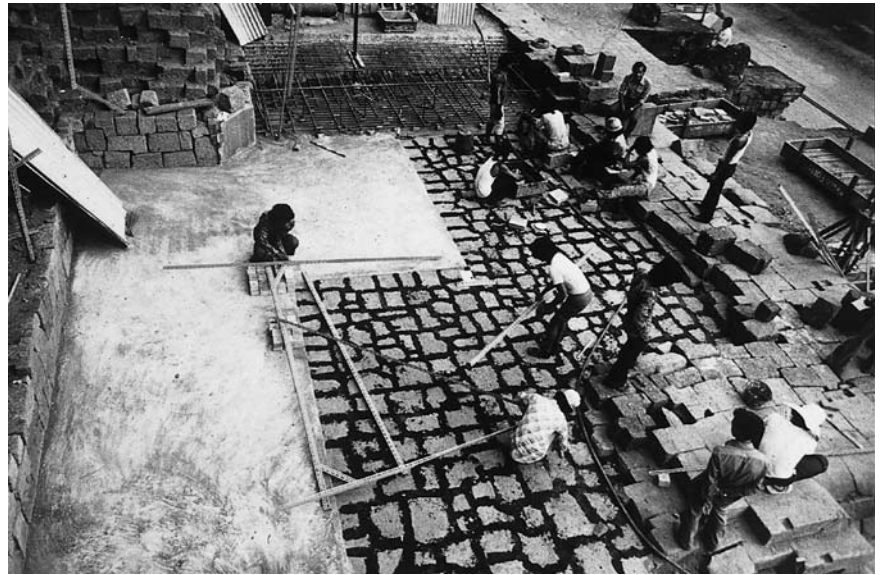
**Photo 6.2.4.1**  
**Rebuilding scheme**  
**North/South**  
 Source: Borobudur  
 Restoration Project

before proceeding with the following stage. If the trial rebuilding showed an irregularity in the course of the band, as it usually did, the correction had to be repeated. This involved dismantling the reconstructed wall, which consisted of seven or eight layers of stone. This procedure had to be repeated many times.

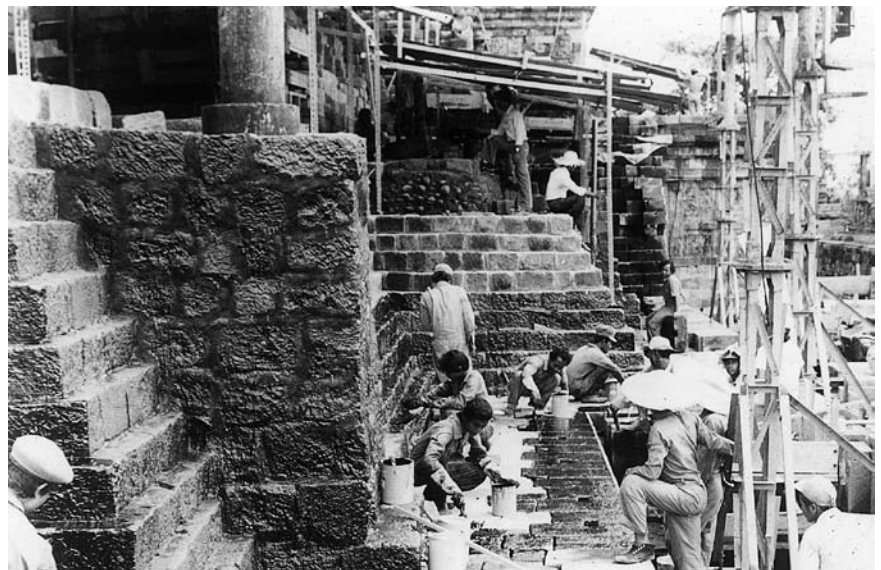
**Photo 6.2.4.2**  
**Rebuilding scheme**  
**East/West**  
 Source: Borobudur  
 Restoration Project
