The Restoration of Borobudur

United Nations
Educational, Scientific and
Cultural Organization

Published in 2005 by the United Nations Educational, Scientific and Cultural Organization
7, place de Fontenoy F-75352 Paris 07 SP

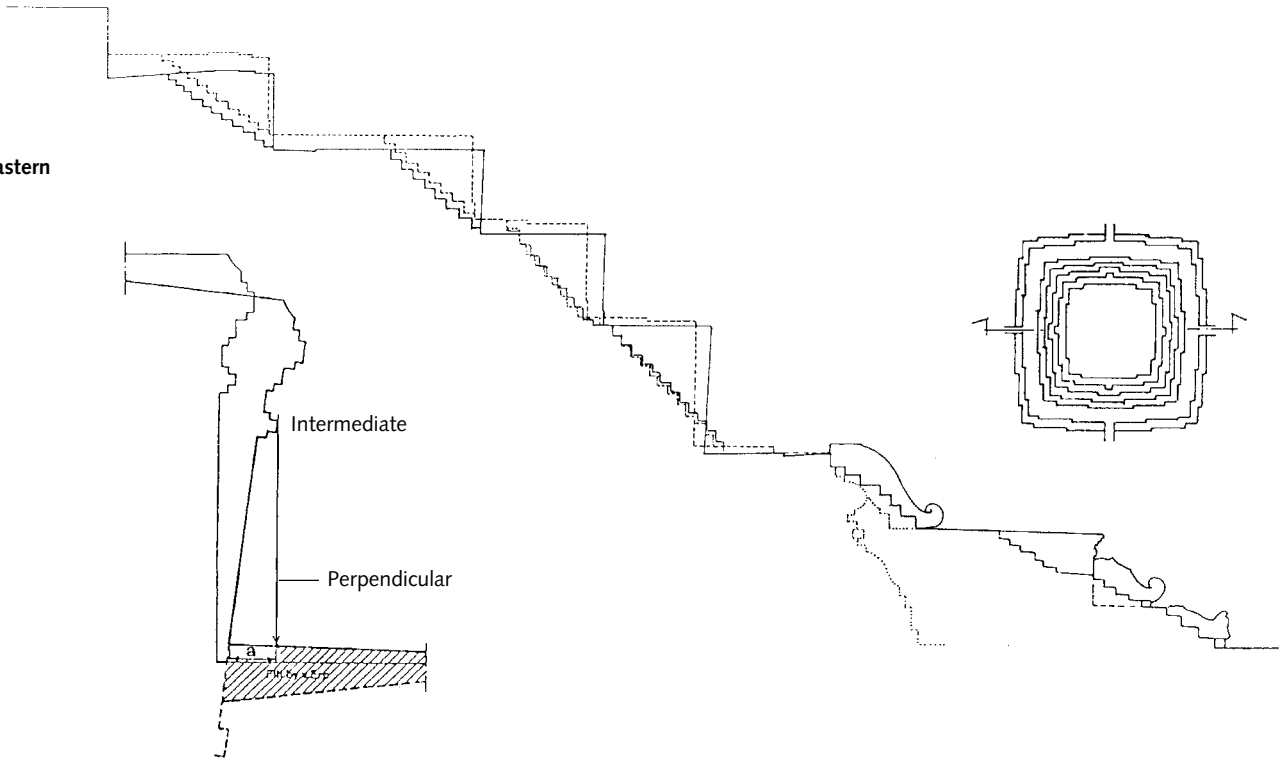
Figure 5.4.1
Cross-section of eastern staircase
Source: Borobudur Restoration Project

Checkpoints on the stones of the wall and on the floor were established for easy measuring purposes. This was done in the simplest possible way: by using a plumb line, lowered from the extreme edge of the intermediate listing point to the marked point on the floor. The base of the resulting triangle, showing the distance from the foot of the wall to the checkpoint, was used as the parameter of the degree of slanting.

Measurements over a period of nearly fifty years did not reveal alarming symptoms with respect to the process of slanting of the continuously observed wall. However, the alternations between increase and decrease undoubtedly indicated the occurrence of movement, and could therefore not be ignored. It was not improbable that the movement

took place behind the wall and that the cause was the alternating swelling and shrinkage of the subsoil.

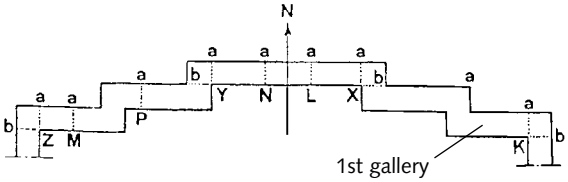
Photo 5.4.1
Walls
Source: Borobudur Restoration Project

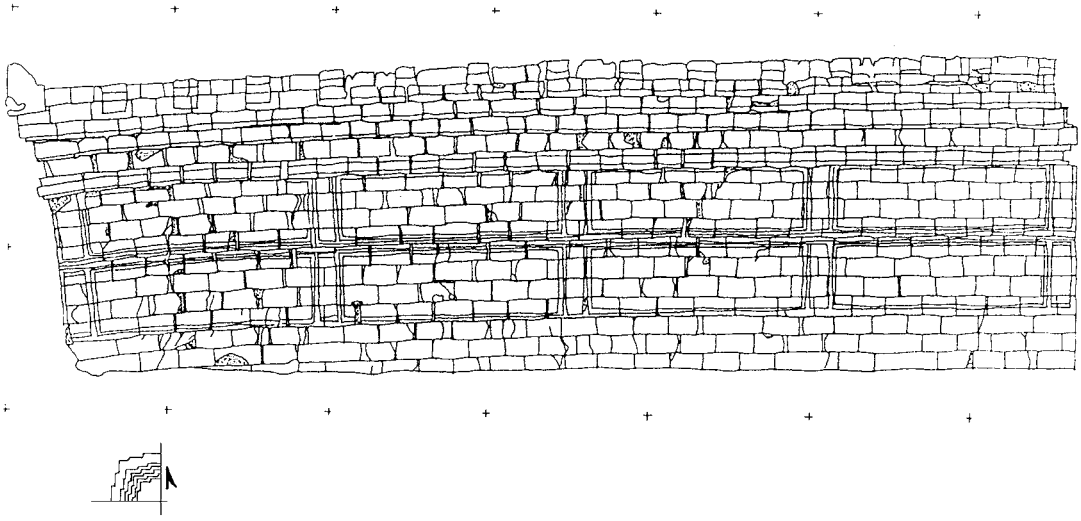
Figure 5.4.2
Tilting of main wall
Source: Borobudur Restoration Project

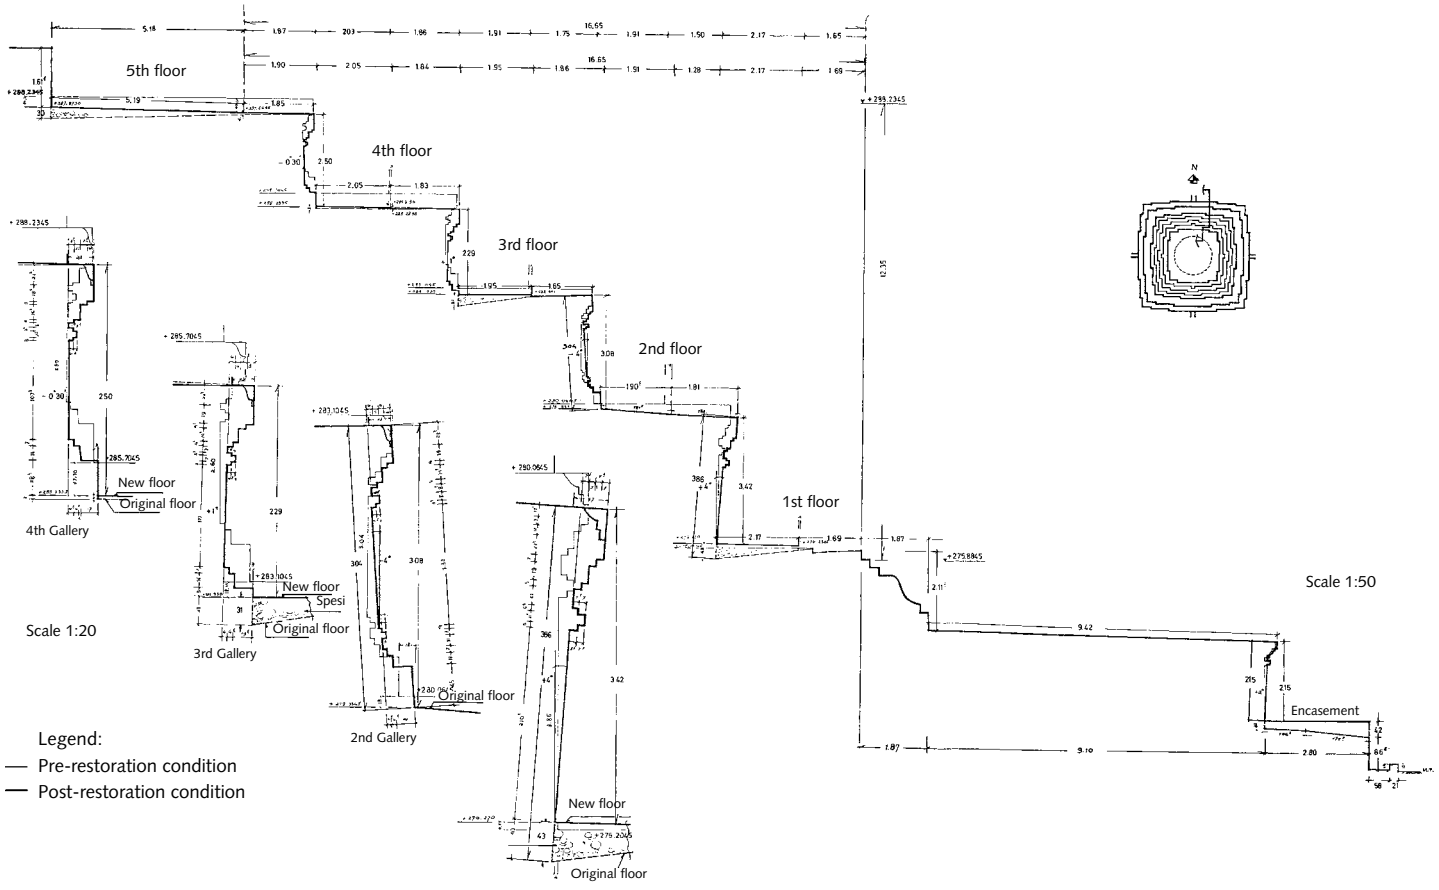
Figure 6.1.3.1
Cross-section of east section, north gate
Source: Borobudur Restoration Project

The structure was to be re-levelled on the basis of four reference lines defined in October 1973. They were chosen with the agreement of Dr Soekmono, General Secretary of the project. These four lines were to be horizontal after reconstruction; for the first gallery the reference line was the lower line of the median decorative band and, for the second, third and fourth galleries, the reference line was the edge of the plinth. For the first gallery the reference line had a height of 277.91 metres, for the second a height of 280.77 metres, for the third a height of 283.31 metres, and for the fourth gallery 285.88 metres.

The height given per section in Figure 6.1.3.1 is of the planned floors; each long section had an intermediate point as requested in the work description (issued October 1972; see Annex Table 3–10)

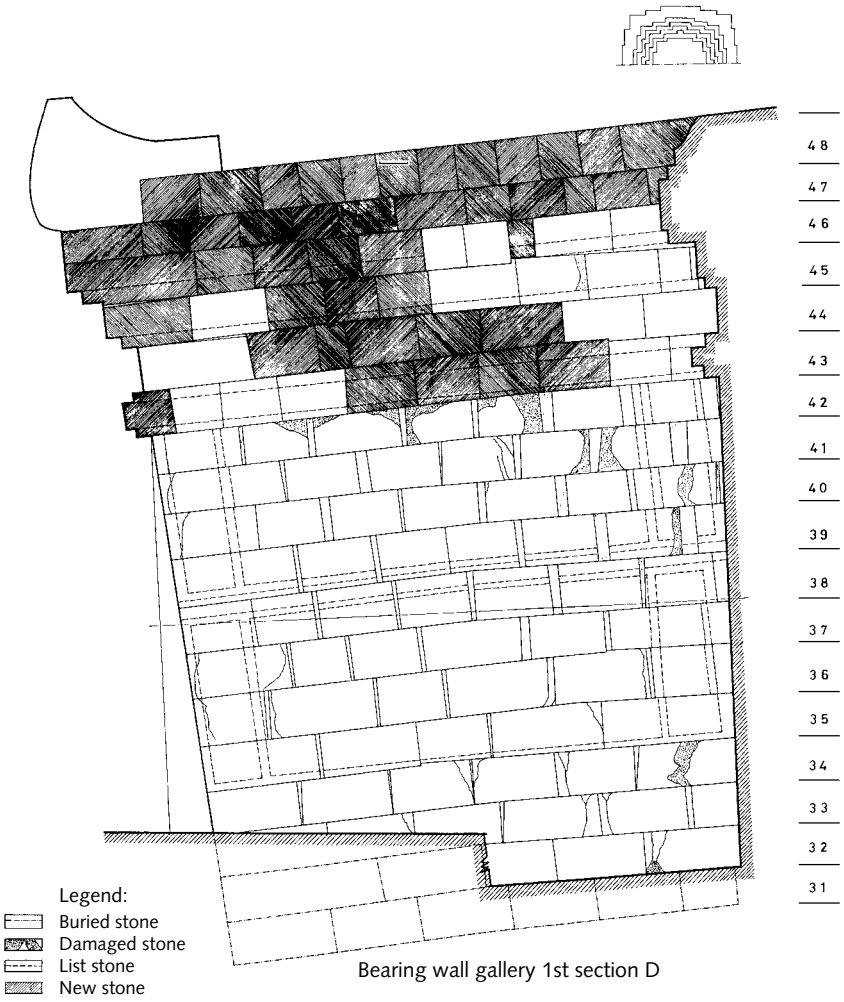
Figure 6.1.3.2
Rotation of tilting walls
Source: Borobudur Restoration Project

1. The length of each wall section was calculated, taking into account the elimination of the wide joints. The length of the wall sections was measured as follows:
   i. The total length of the wall section was measured before dismantling (L).
   ii. The length of each individual stone was measured (S).
   iii. The width of each joint was measured (W): see Figure 6.1.3.4.
   The design length was taken as: SS + (L – SW)/2.
   All measurements were taken twice.
2. The walls were shifted backwards in accordance with the decrease in length of the walls on the south and north sides.
3. The staircase was shifted backwards, but remained on the same east–west axis.
4. The width of the staircase was kept constant.
5. The corner points were laid out, beginning from the staircase.
6. In repositioning the walls, the angle of the outer corners was kept constant. The

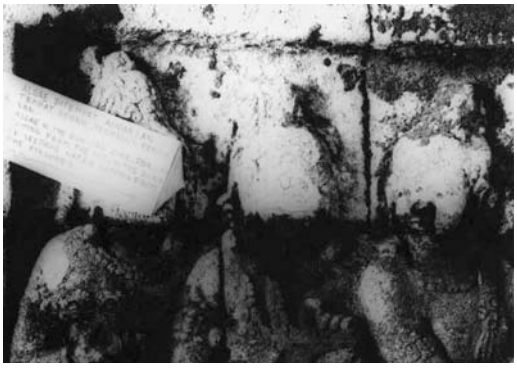
Photo 6.1.5.8
Algae in the runoff water
Source: Borobudur Restoration Project

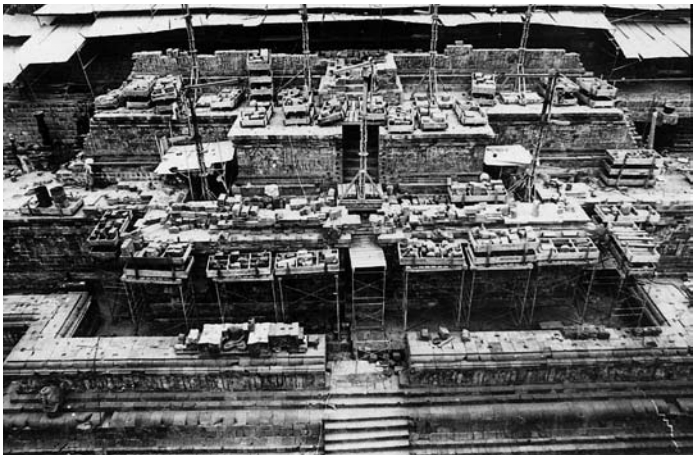
Photo 6.2.1.5
Rebuilding work on the east side, on both sides of the stairs

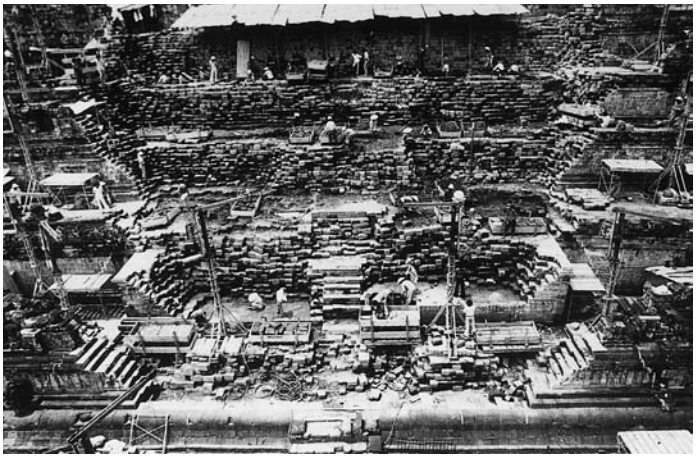
Photo 6.2.1.6
Dismantling of stones on the west side

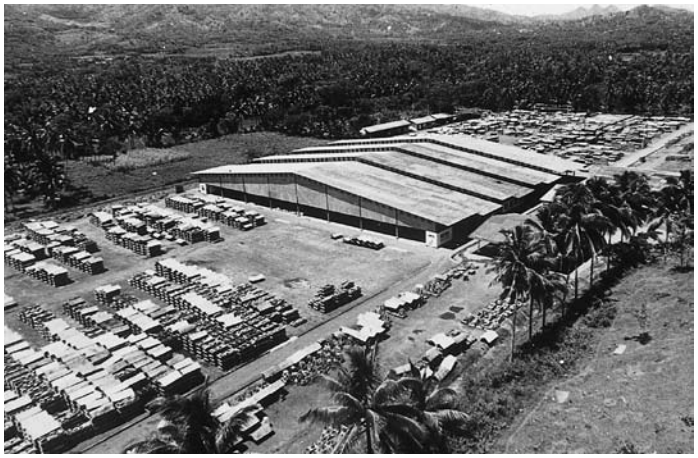
Photo 6.2.2.1
Workshop for stone treatment

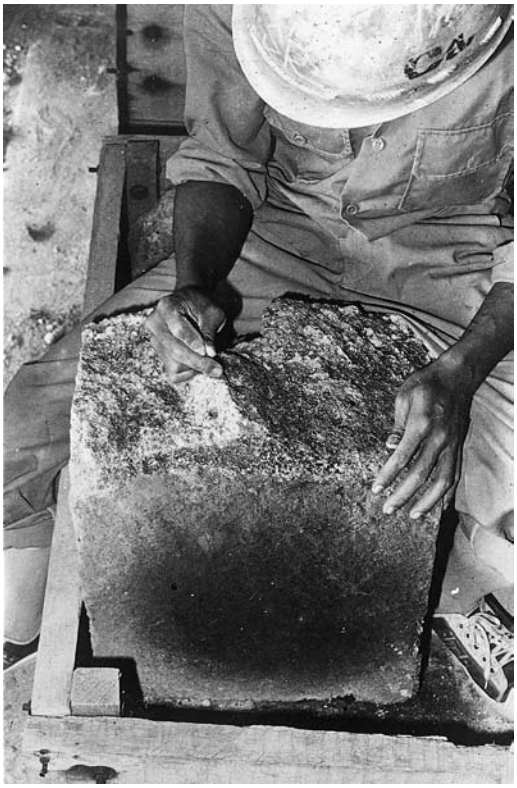
Photo 6.2.2.6
Elimination of rhizomes of mosses in the pores of the stones using a fine needle
Source: Borobudur Restoration Project

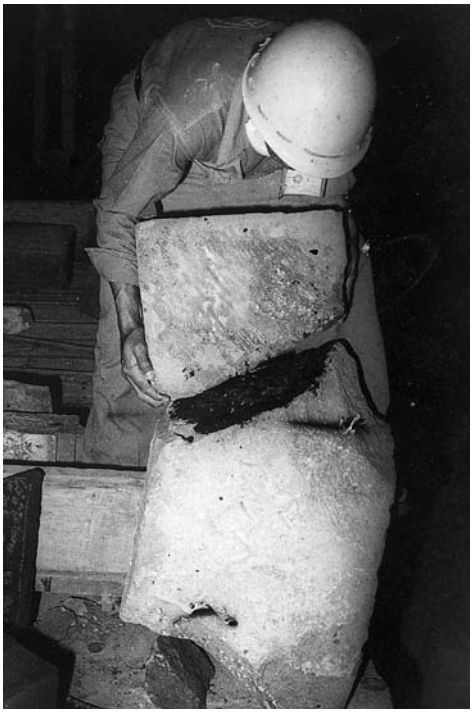
Photo 6.2.2.8
Stone binding
Source: Borobudur Restoration Project

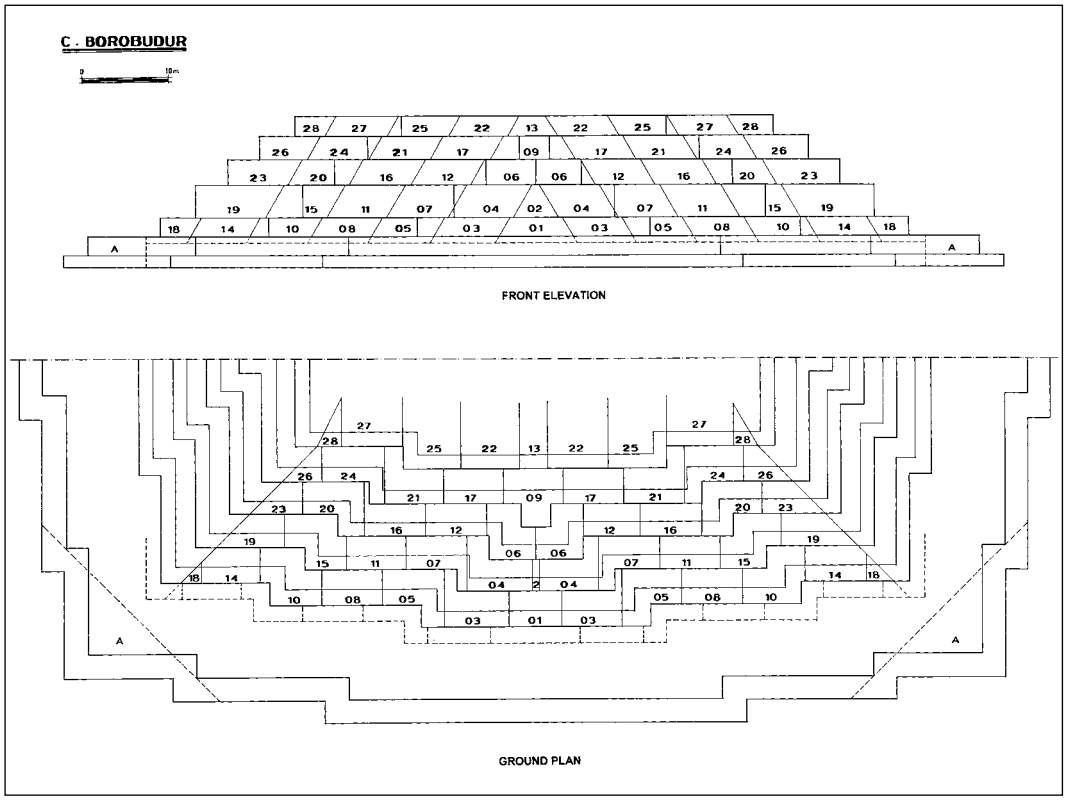
Figure 6.2.4.1
Rebuilding scheme North/South
Source: Borobudur Restoration Project

To position the reconstructed walls and balustrades correctly, certain points and lines were fixed as references. The reference line for the first gallery was fixed at the centre line of the band separating the upper and lower rows of relief panels, at a height of 277.191 metres. For the second, third and

fourth galleries the line of the plinth – the edge of the stones of the second layer above the floor – was fixed as reference at respectively 280.77, 283.31 and 285.88 metres. Corner points were situated on these reference lines.

The process of dismantling and rebuilding at the north and south sides of the monument was extremely instructive, in the sense that the experience gained provided a solid base for the reconstruction design of the other sides. These east and west sides posed fewer difficulties since no significant structural deviations had been observed, and thus no drastic changes were required. Nevertheless, the design coordinates did need to be revised.

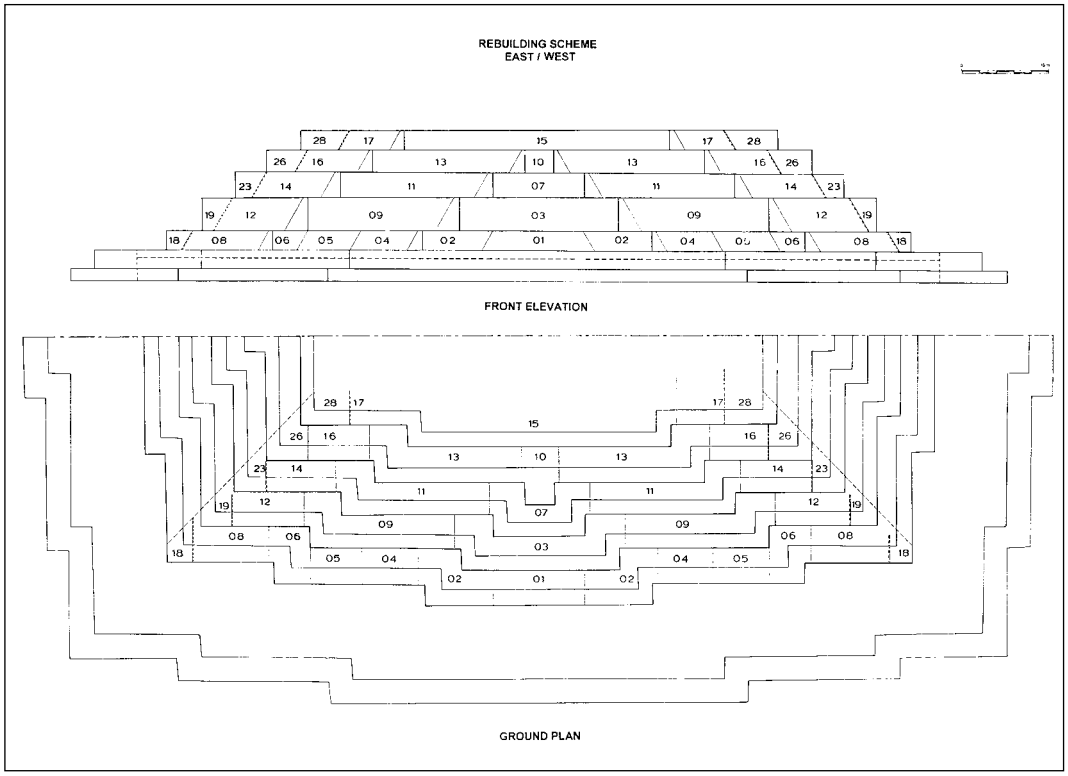
Figure 6.2.4.2
Rebuilding scheme East/West
Source: Borobudur Restoration Project

The rebuilding work on the north and south sides caused several changes in the overall plans. The schedule for rebuilding one side, expected to take thirty-nine months with a workforce of eight members per team, could not be realized. The working areas were not spacious enough to permit more than five

people to work simultaneously. Moreover, since the rebuilding was in fact only part of a complicated series of activities in a network of planned operations, the constraints that were experienced provided a sound basis for revising the work schedule and reorganizing the work teams.
