DESIGN BRIEF FOR PHASE 2 OF THE BELMONT PLAN (FONTENOY SITE) AND REPORT ON THE RESTORATION AND IMPROVEMENT OF UNESCO HEADQUARTERS (MIOLLIS/BONVIN SITE)

DESIGN BRIEF FOR PHASE 2 OF THE BELMONT PLAN (FONTENOY SITE)

REPORT
ON THE RESTORATION AND IMPROVEMENT
OF UNESCO HEADQUARTERS IN PARIS
MIOLLIS/BONVIN SITE

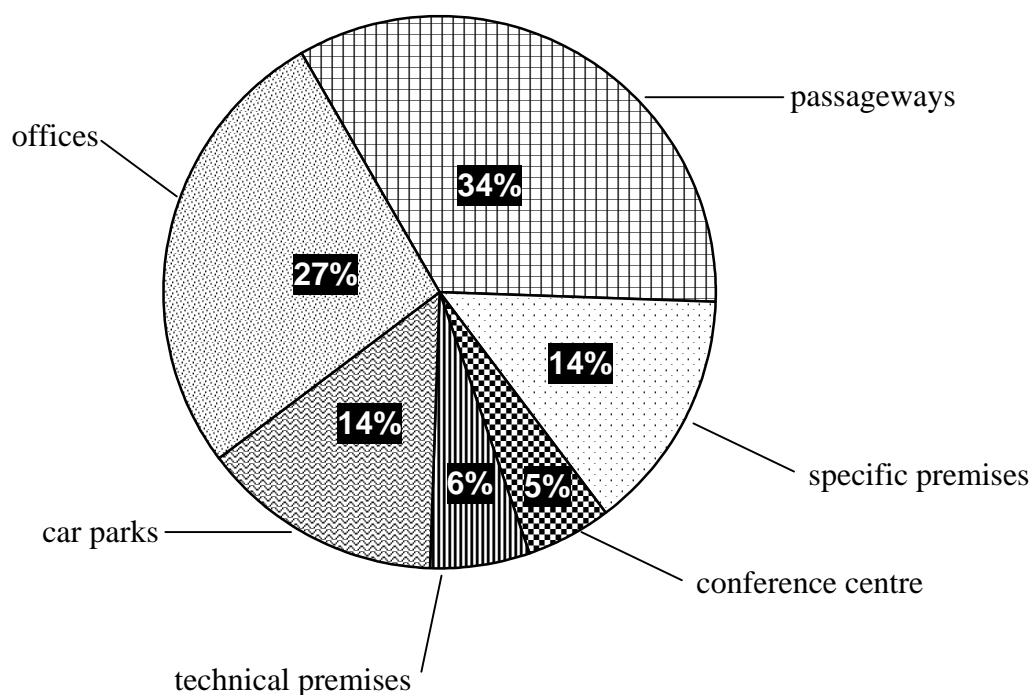
7. In connection with the design brief, a new study has been carried out on the occupation of offices at the Headquarters of the Organization. A summary of the findings can be seen in the following diagram:

8. The diagram highlights:

the large amount of space occupied by passageways, accounting for a third of the surface area, which arises both from the nature of the premises and the architectural design of the buildings;
